## Refurbishment of cavitated Thruster unit

<b>Application:</b>	Repair of Thruster unit
<b>Place:</b>	Farmsum, NL
<b>Date:</b>	September 2016
<b>Job and report done by:</b>	Marine Maintenance Services, NL
<b>Wencon products used:</b>	Ceramic Cream, Ceramic Coating, Cleaner, appl. tools

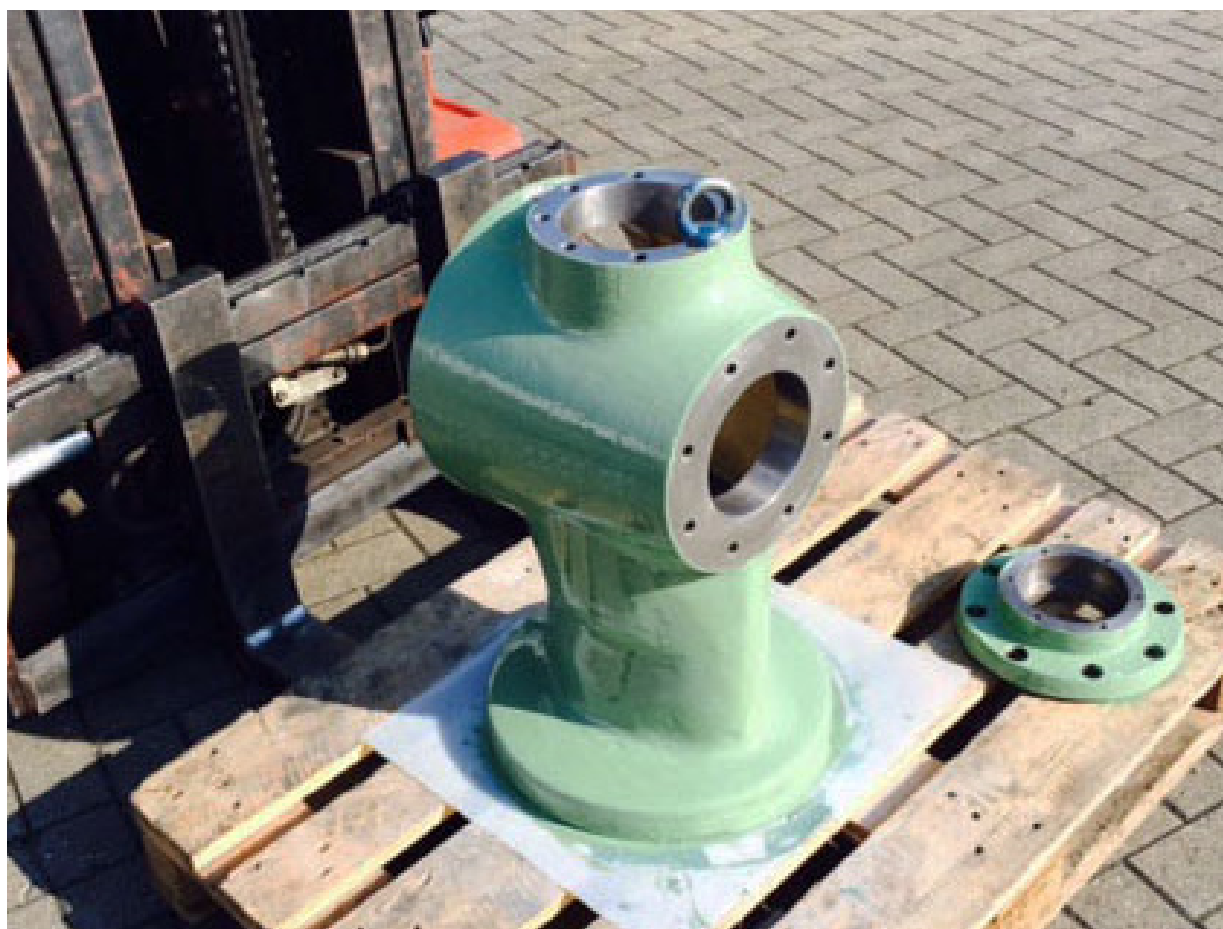
1.  
Shaft of the thruster is leaking with a lot of oil and after inspection it is clear that there is wear of the seal. Lead time of shaft is approx. 7 weeks.

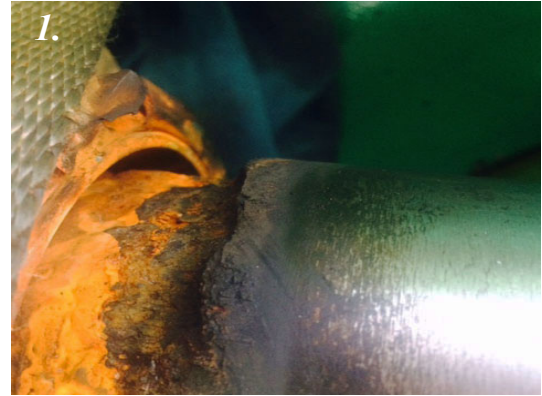
2.  
By dismantling the Thruster unit, a lot of cavitation is discovered on the housing and shaft is completely destroyed, due to wear.
