Cooler End Cover, corroded

A.1016

Bi-metallic corrosion

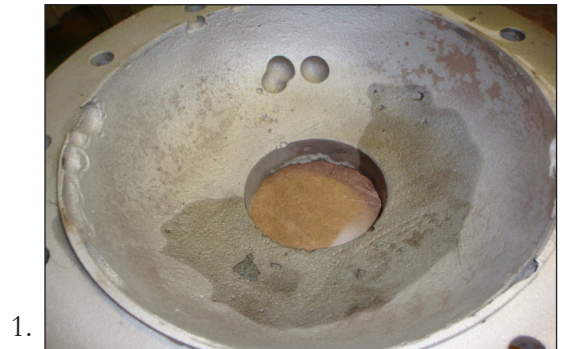
1. End cover after shotblasting
2. End cover rebuild with Wencon Cream.
3. After application of Wencon Coating white
4. Ready for remounting the end cover. Seawater is now separated from the metal, ready for many years of service without corrosion problems.

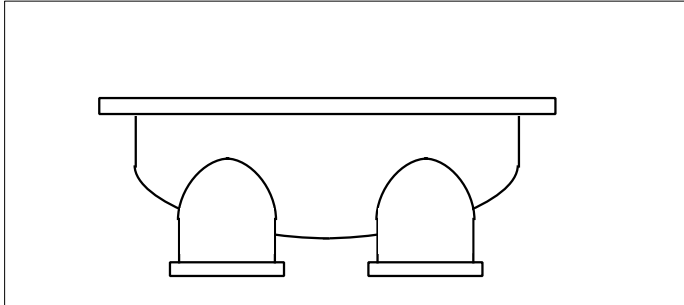
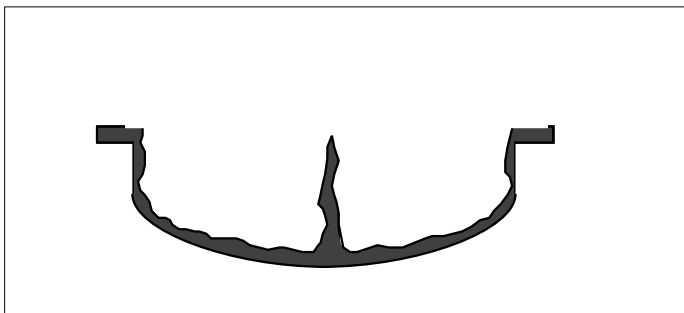
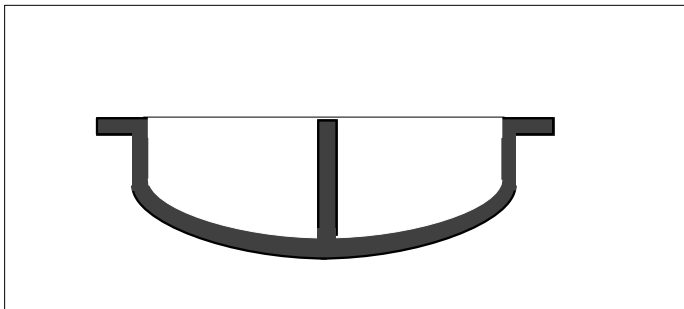
Repair of corroded cooler end cover

Corroded cooler end covers are very common problems on board a ship. There are several ways of dealing with this. A temporary repair can be made, or the repair can be of a longer lasting nature. The latter method necessitates shot blasting, which as a rule is undertaken ashore. Grinding or needle gunning are other means of carrying out the preparatory work. It is important to remove the graphite as the aim is to obtain a clean metal surface. The inlet and outlet end cover is shown here.

1. Disassemble the end cover and carry out the preparatory work. Finished by cleaning with Wencon Cleaner.
2. Build up the end cover to its original shape with Wencon Cream or Rapid. If there are holes in the metal, whether in the outer sides or in the division bar, it will be an advantage to reinforce the repair with either Wencon Reinforcement Tape or a piece

of metal mesh. The metal mesh is particularly advantageous with big holes as the rigidity of the mesh makes application easier.

Apply the Wencon well beyond the edges, and after curing grind away the surplus with a wheel grinder.

3. Build up also the edge of the division bar and prior to curing fit and tighten in place a piece of angle iron or the like, on the flanges, in such a manner that the division bar is given its required shape. The iron rail is treated with Wencon Release Agent before tightening in place.

After rebuilding and partial curing brush a layer of Wencon Coating, white over the entire end cover. Allow to cure for 1-2 hours, then finish with a coating of Wencon Coating, blue.
