TECHNICAL REPORT

MIKO MARINE A.S

QUALIFICATION OF MIKOPLASTER

REPORT No. 530 10221/98

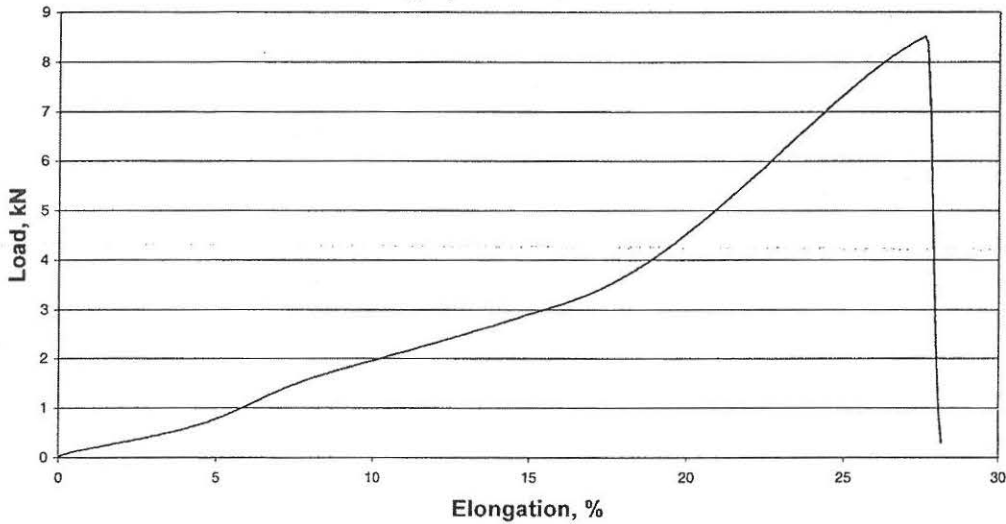
Tensile test No 1

In the short term tests the strips were pulled to failure at a strain rate of approximately 0.5 %/s. The following results were recorded:

Tensile strength	mean ¹⁾ :	212	N/mm ²⁾
“	standard deviation ¹⁾ :	8	N/mm ²⁾
Elongation at failure	mean ¹⁾ :	27	%
Elongation at fracture of rubber sheet:		≈ 14	% (estimate)

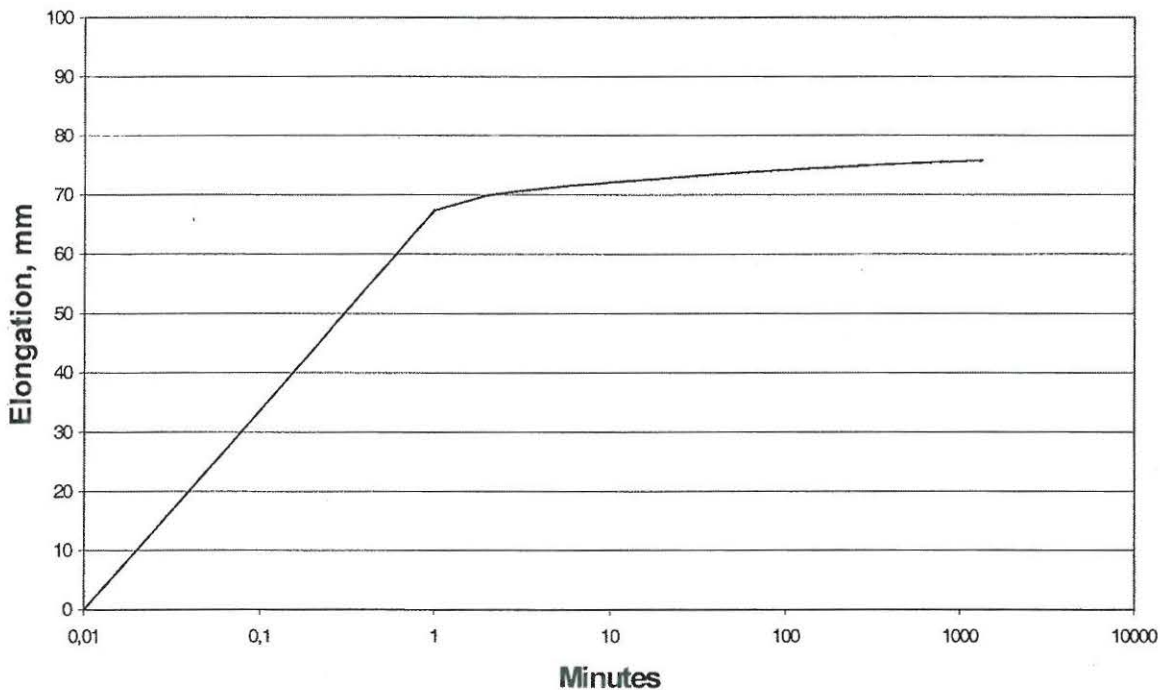
Creep test, 50 % of mean tensile strength

The creep test were carried out on the same type of specimens. Three specimens were tested. The specimens were loaded by a constant load equal to 25 %, 50 % and 75 % of the mean tensile strength respectively, until failure or for a period of 24 hours, whichever occurred first. The elongation of the specimens were logged at regular intervals such that a graph of elongation versus the logarithm of time could be produced. A copy of such a graph is given below. All specimens exhibited a similar behaviour, i.e. a relative rapid elongation during the first minute until a slow more or less steady rate of creep was established.

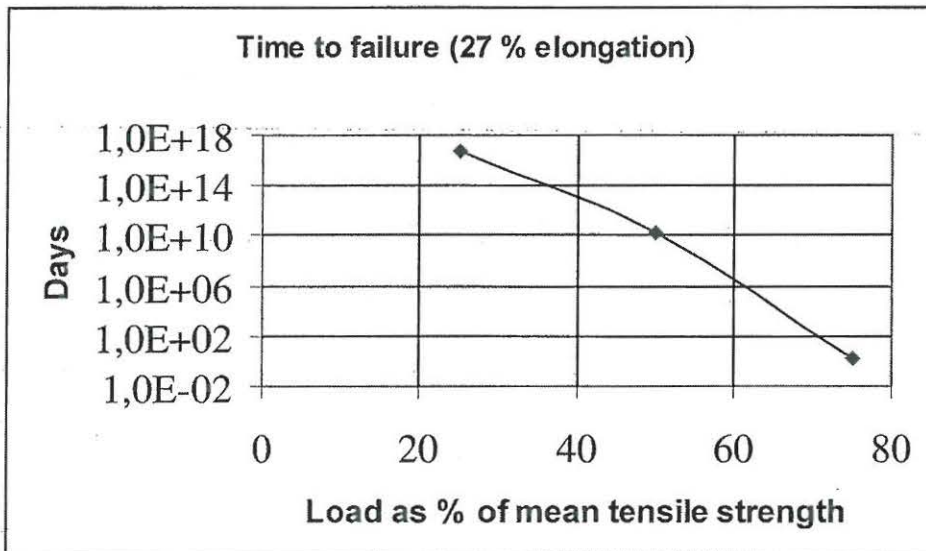
For each specimen a straight line was fitted by hand to the upper slow rate part of the curve. This line was extrapolated to an elongation of 27 %, which was defined as failure of the specimens, thus giving time to failure. These times to failure were plotted versus the load on the specimen as shown in the following graph.

In the QP it is specified that the tarpaulin shall sustain a water head at least 1,5 times higher than the water head at which it is operated. This means that the load on the tarpaulin shall as a maximum be equal to $1/1,5 = 0,67$ of the tensile strength. The fact that no damages to the fabric were observed at the full scale tests indicates that load is even lower. From the curve above and this latter observation it is evident that at such a load a creep failure will not occur until some 100 days have passed.

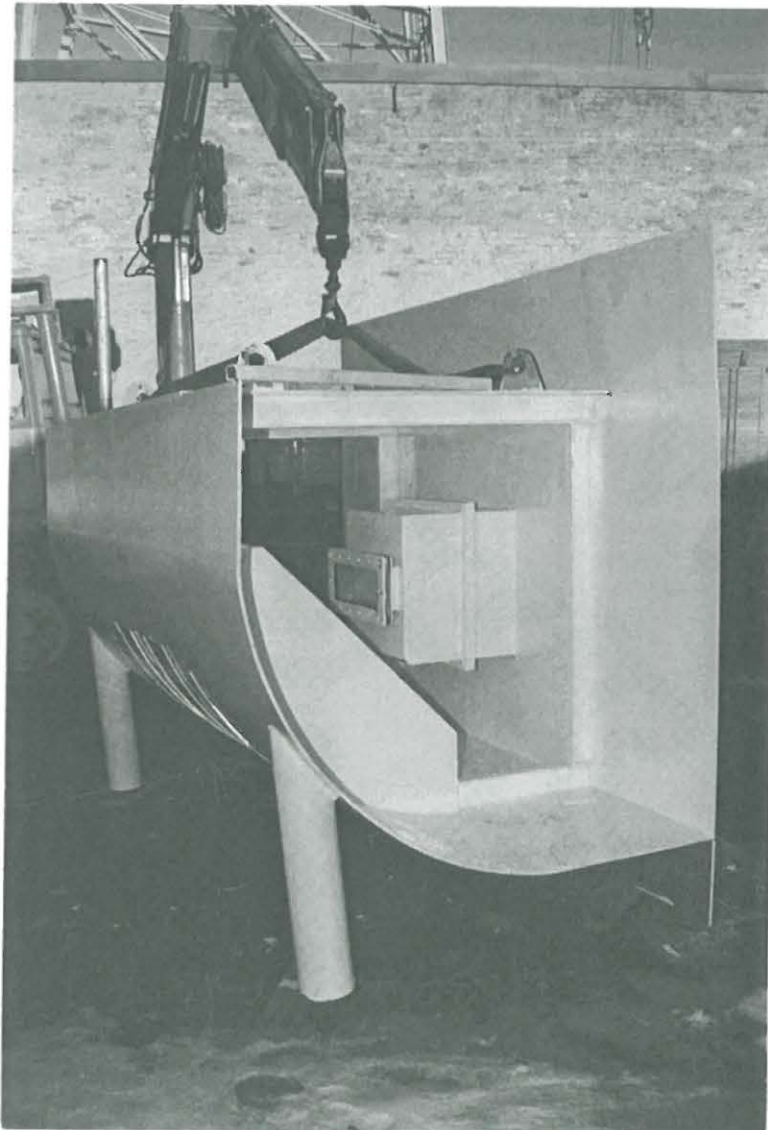
Fig. 1: Steel structure

For the full scale tests a steel test structure was manufactured, Figs. 1 - 3. The structure consisted of steel plating representing a flat hull side and a single curvature (e.g. a bilge) with a radius of curvature of 1 m. On the flat side a circular opening was provided with a diameter of 500 mm. On the curved side an opening simulating a sea chest was provided with dimensions 800 x 1 700 mm. The "sea chest" opening had an aluminium grating fitted (similar to gratings normally fitted in sea chests) which supported the tarpaulin and carried the load from the hydrostatic head. The circular opening was tested with a support for the same purpose consisting of a steel profile fitted in the centreline.

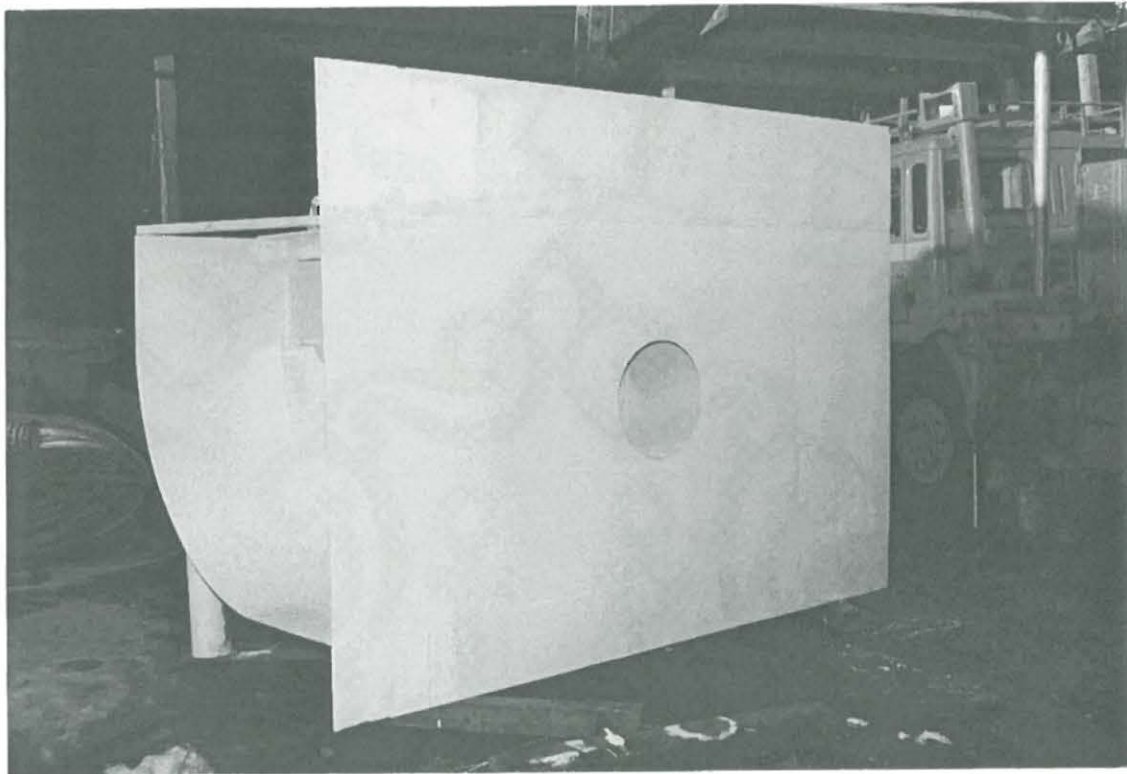
Fig. 3: Circular opening

The curved side contained one butt weld with an approximately 3 mm high reinforcement that went from the edge of the opening to the edge of the plate.

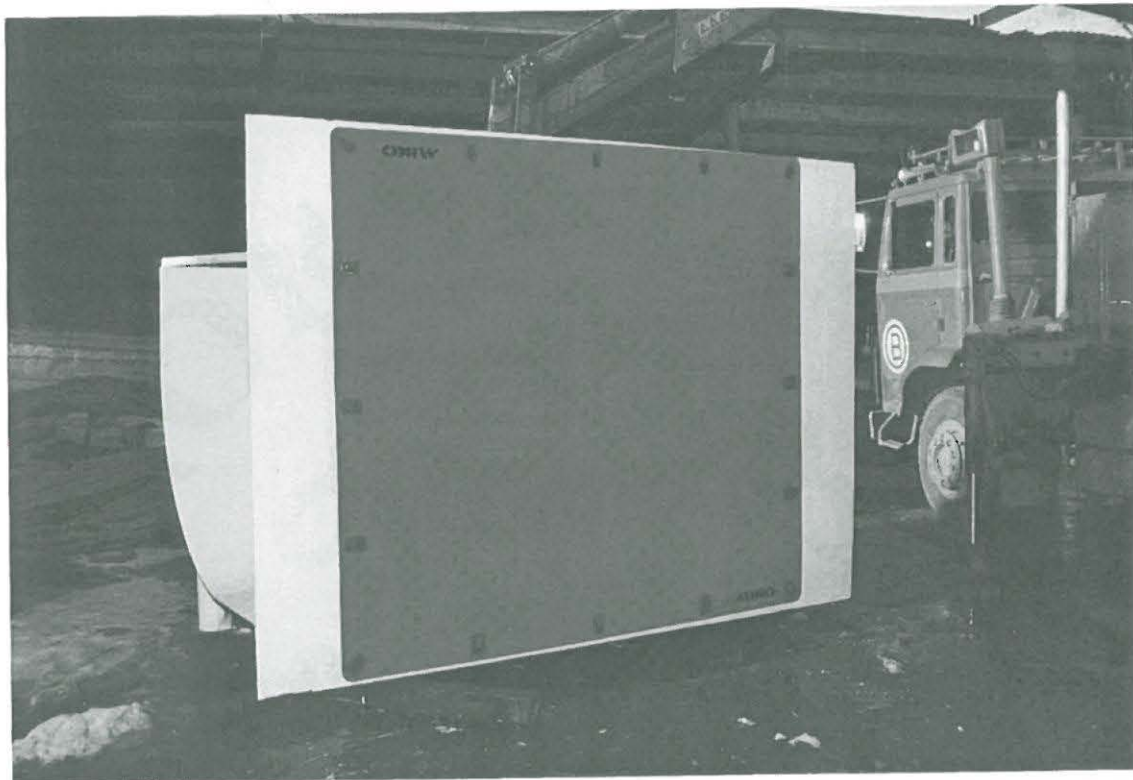
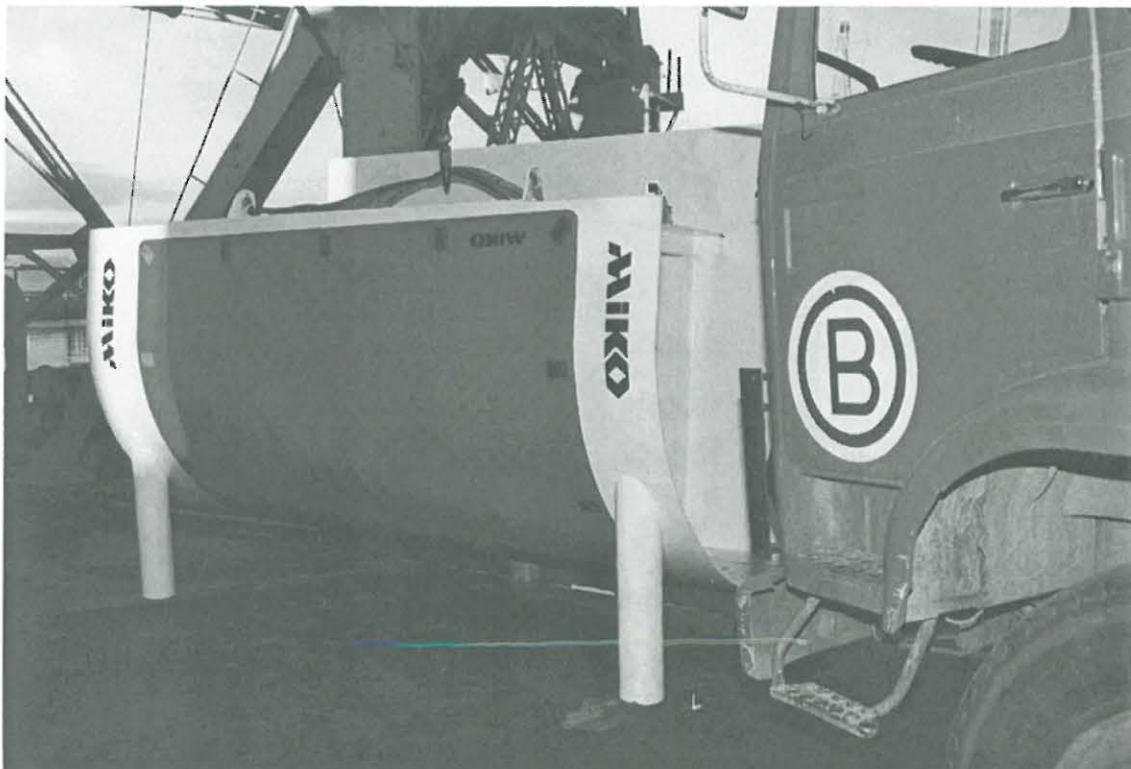
Photographs of the steel structure with tarpaulins mounted over the two openings and prepared for testing are shown in Figs. 4 and 5. The tarpaulins were mounted by lifting them on place by hand. For testing of the first two items the structure was brought out to sea on a tug and lowered into the water by means of the on-board crane.

- No damages to the polyester/PVC fabric could be observed.
- The rubber sheet exhibited extensive cracking inside the perimeter of the openings, particularly at edges of the openings and the supporting grating and steel profile.
- Water had penetrated into both containers. The leakage behind the circular opening was small, of the order of 2 – 3 litres of water had penetrated. By estimating the volume of water in the container behind the sea chest the leakage rate was estimated to 25 – 50 litres pr hour.

Fig. 4: Tarpauling mounted over circular opening

Fig. 5: Tarpauling mounted over sea-chest opening

The minimum distance between the edge of the tarpaulin and the edge of the opening shall be 400 mm. This shall be reflected in the user manual.

It is DNV's conclusion that MikoPlaster has sufficient structural strength when used as during the tests that has been carried out. The tarpaulin shall be supported for each 100 mm at 20 m water head. This shall be reflected in the user manual.
