SWISS Solutions Moulded Grating

Renewing of the gratings on board of the Dutch M/V Arca under the oil sweeping booms.

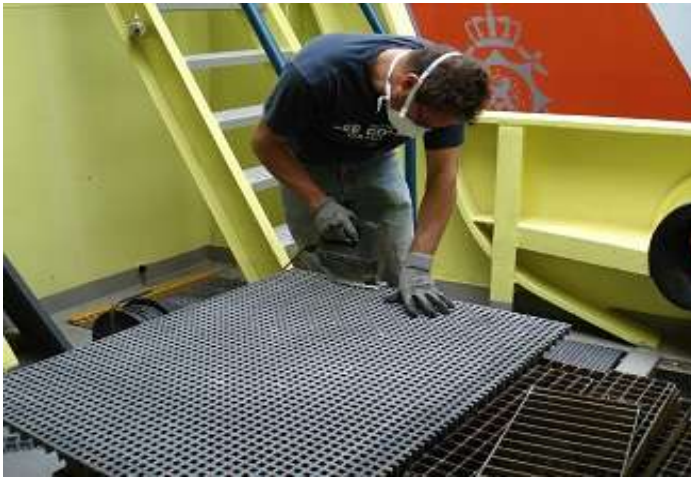
Cutting panels with Jigsaw

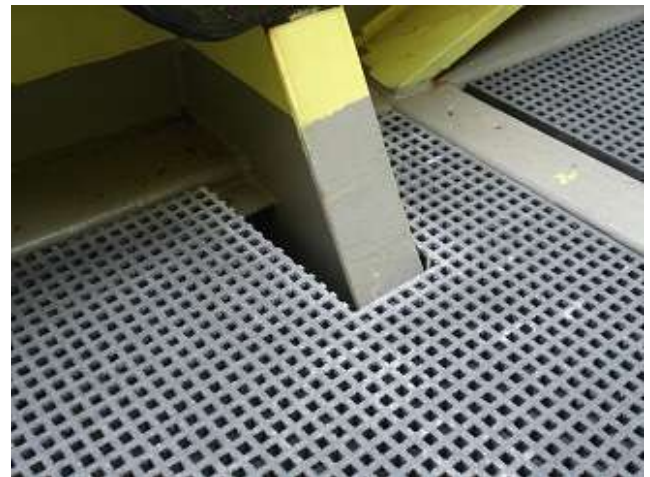
Only small cuts had to be made on board

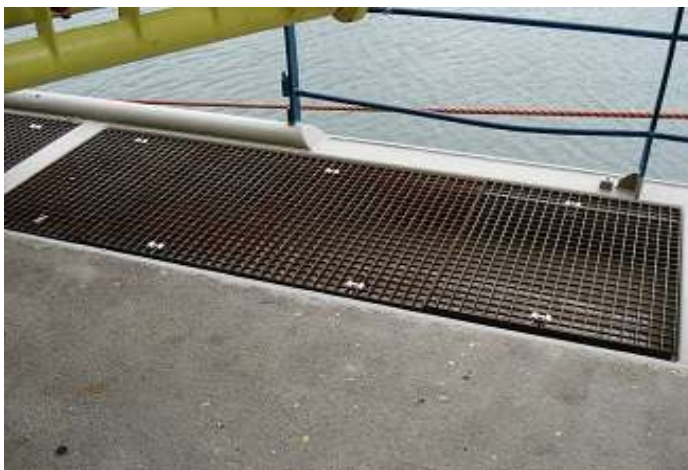
For many years galvanised gratings are used. The problem of this type of gratings are especially on board of seagoing vessels that in this environment they start corroding. Another problem is when the area under this gratings must be cleaned those panels very heavy so its for the crew not the most easy to handle this.

Before, the corroded steel gratings

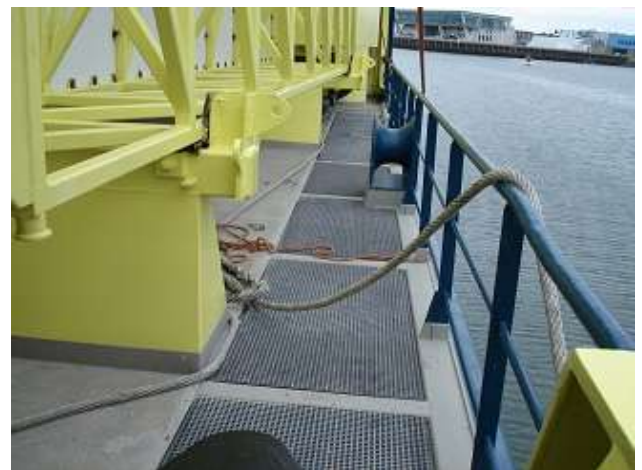
After, the new Swiss Solutions Gratings

They have chosen now for the Moulded Gratings with an embedded grit top surface from Swiss Solutions because all of the benefits of this product. This Moulded Gratings are supplied in a standard Grey colour and where cut in the right dimensions in the factory. Only small cuts at some points had to be made on board.
