WITH WENCON LESS DOWNTIME

RMN WENCON GRE PIPE REPAIR

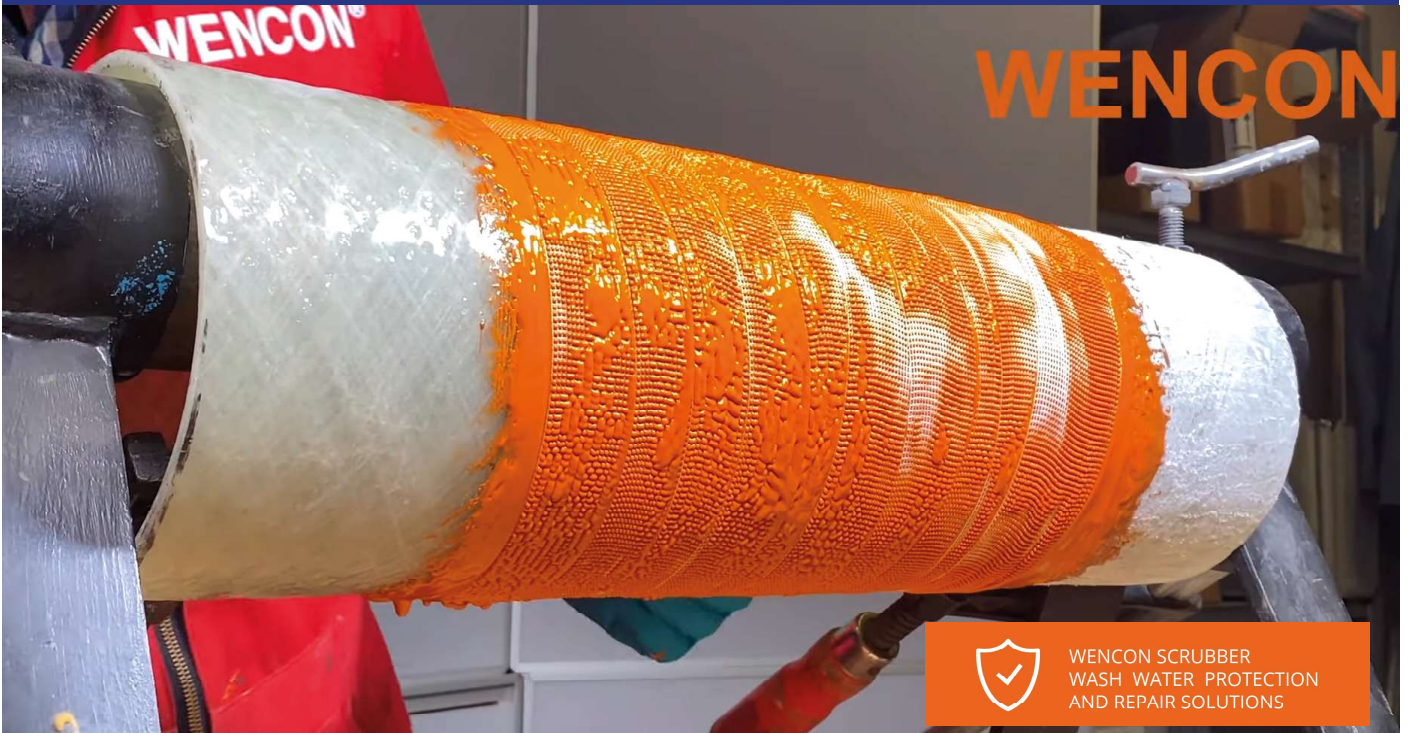
These days many vessels have GRE Piping Systems on board. They are used for ballast pipes and for exhaust gas scrubber systems. With having this systems on board the demand for repairs is also growing. Wencon developed a repair system using the Wencon UW Coating Products to make a fast and reliable repair of these pipes. Less downtime and strong repairs. Especially due to the demand of this products there are 3 special developed GRE-Pipe Repair Kits. The Kits contains the right amount of products to repair 1 meter length of DN250 - DN500 - DN1000. Repair is done by the Wencon Wrapping Method with 4 layers of UW Coating and 3 layers of Wencon Reinforcement tape. Wencon UW Coating is also used to glue the GRE Pipe Connectors to the GRE Pipe. The method is described at the Wencon Video.
