Repair of Valve manifold

Application:	Repair of Valve manifold
Place:	Vlissingen, NL
Date:	September 2016
Job and report done by:	Minderhoud Techniek, NL
Wencon products used:	UW Cream, UW Coating, Cleaner, appl. tools

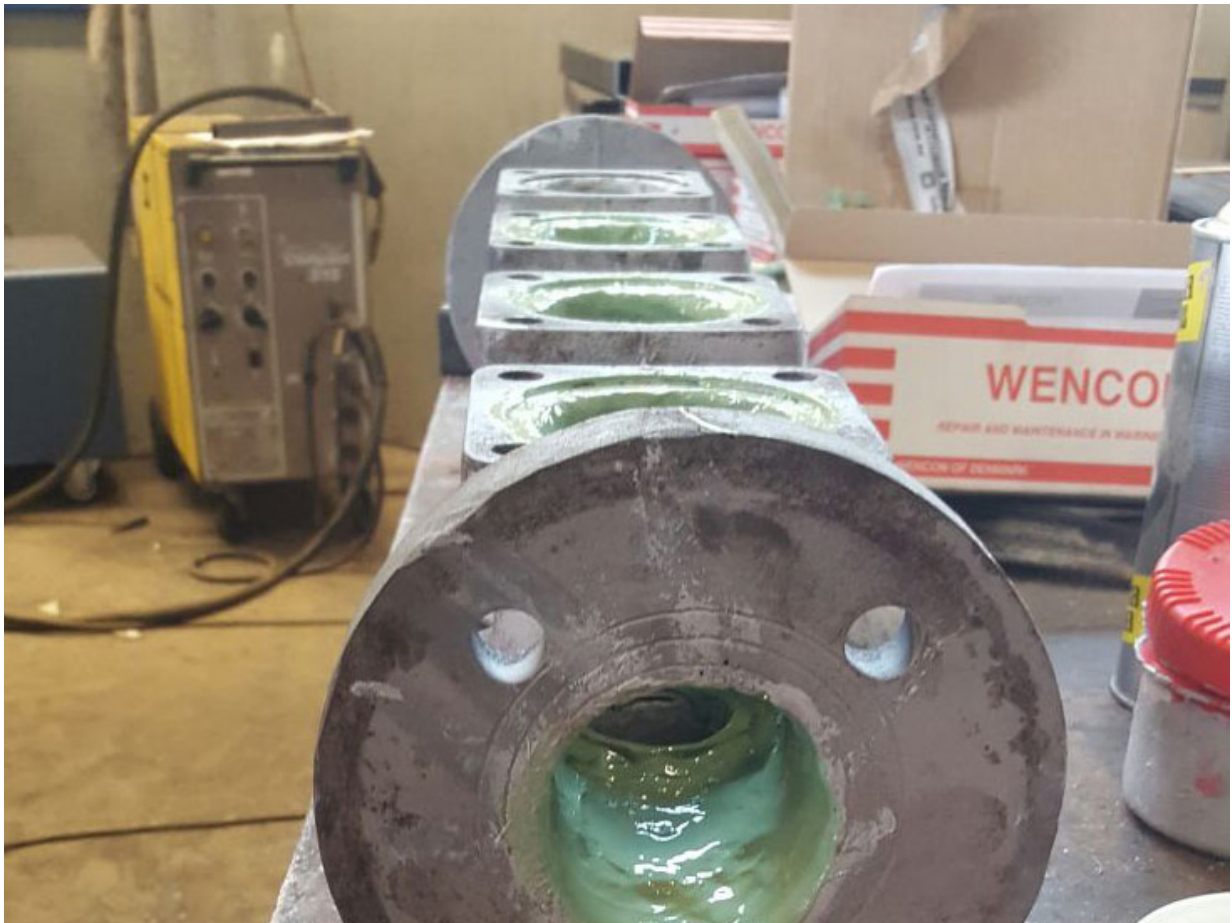
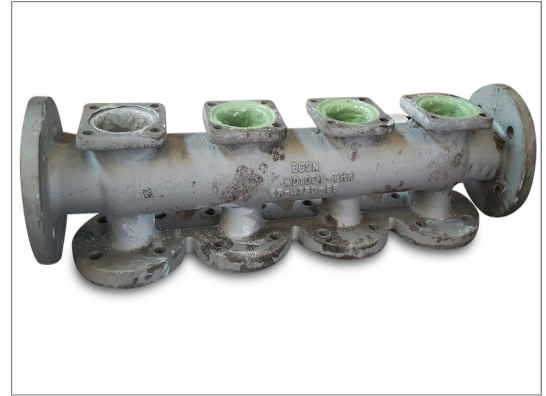
1 & 2

Leaking manifold received at workshop in Vlissingen, with the purpose of temporary repair - due to long lead time of approx. 6 weeks. Manifold was dismantled and shot-blasted to sweat out salt, before application with Wencon UW products
