# Heating Coil repair

## WENCON METHODE HEATING COIL REPAIR

Repair on board of a RoRo Ferry vessel in Rotterdam Port carried out by Venus & de Waard.

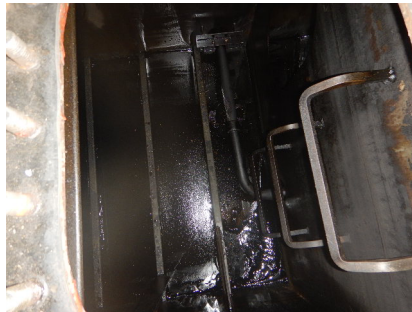
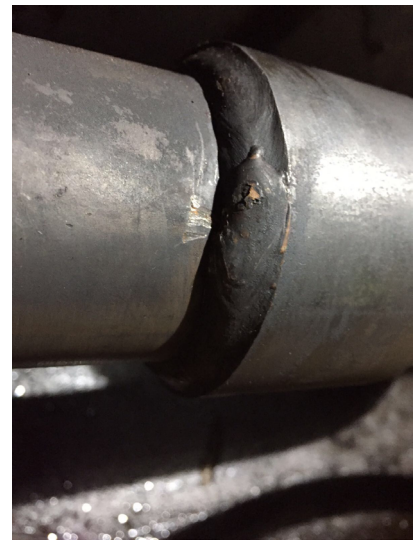
### Surface preparation:

Clean the surface thoroughly using emery cloth and degrease it with Wencon Cleaner.

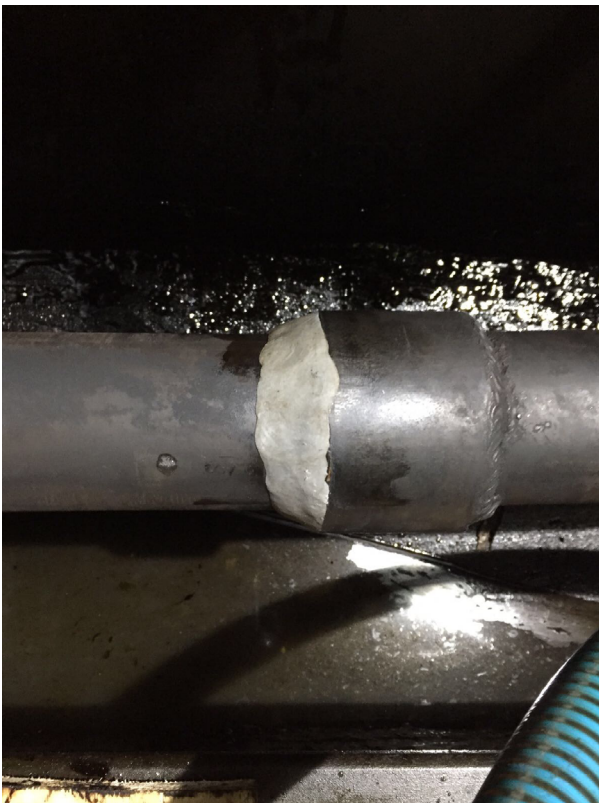
### First step:

Wencon Putty is applied around the complete welding to stop the leak. Benefit of the Putty is that it cures fast.

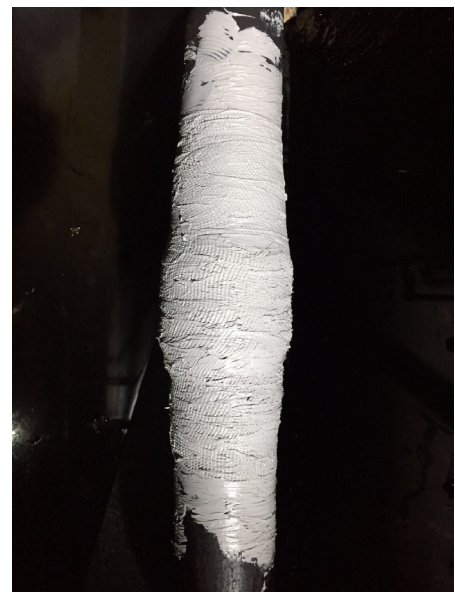
### Second step:

Apply Wencon Rapid in a thick layer and wrap Wencon Reinforcement tape in the wet Rapid for extra strength of the repair. Smoothen the surface over the Reinforcement tape with a spatula.

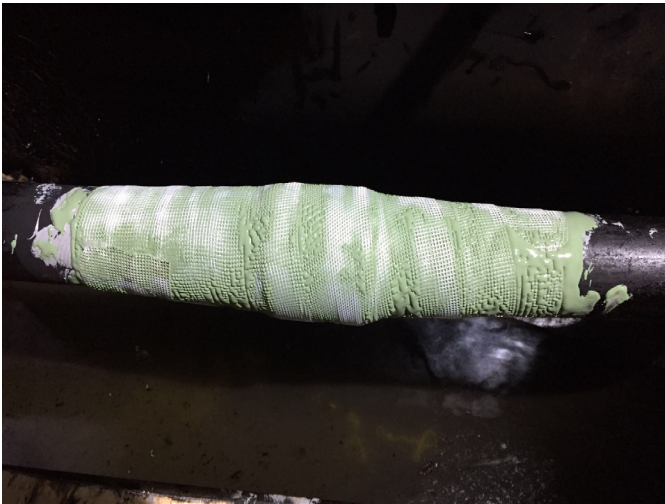
## Second layer:

Apply with a brush Wencon Ceramic Cream over the Wencon Rapid and wrap around Wencon Reinforcement, repeat is at least 2 times.

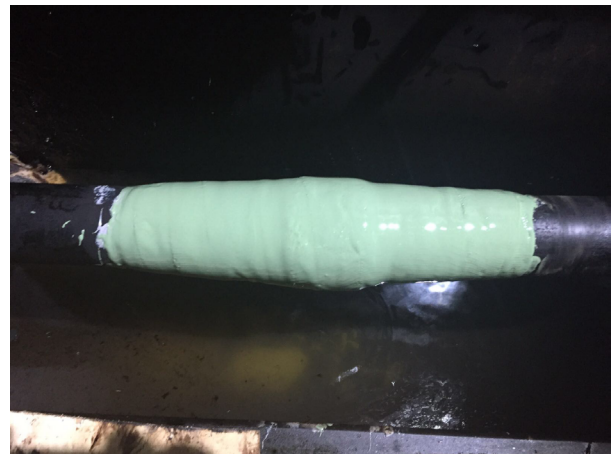
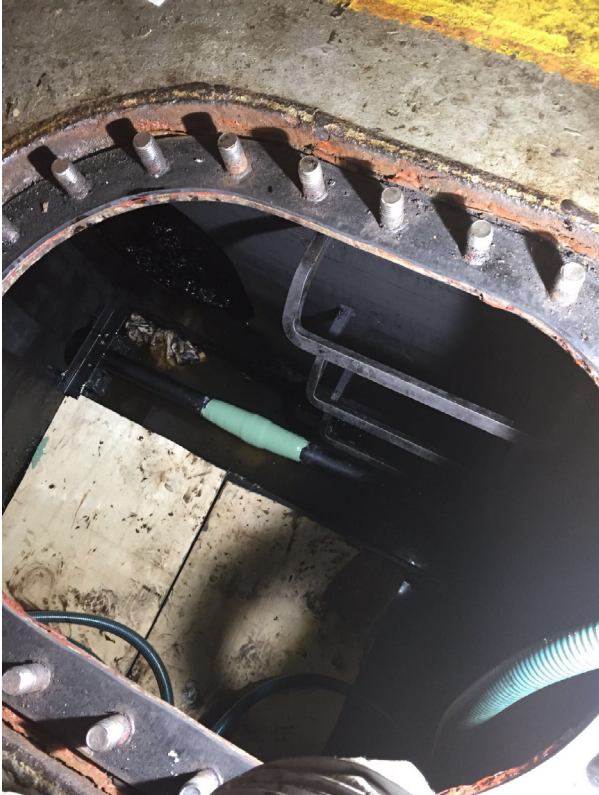
## Final layer:

Apply the final layer of Wencon Ceramic Coating on top of the reinforcement tape and smoothen it with the brush. Let it cure before using the steam pipe.
