## Twin Screw Cargo Pump

A.1027

### Problem

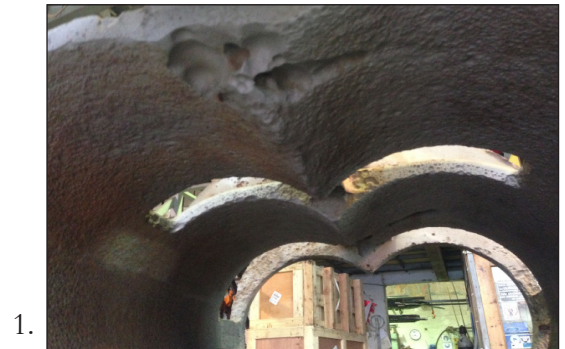
Pump in very bad condition. Casing, insert and rotors heavily attacked by bi-metallic corrosion.

1. Screw chambers attacked by corrosion.
2. After refurbishment, parts are machined to original size and clearance.
3. Chambers rebuild with Wencon Rapid and Hi-Temp, ready for machining
4. Machining after alignment completed.
