Valve Manifold Repair

EMERGENCY REPAIR
CARRIED OUT BY BAS MINDERHOUD TECHNIEK VLISSINGEN
OFFICIAL WENCON SERVICE PARTNER

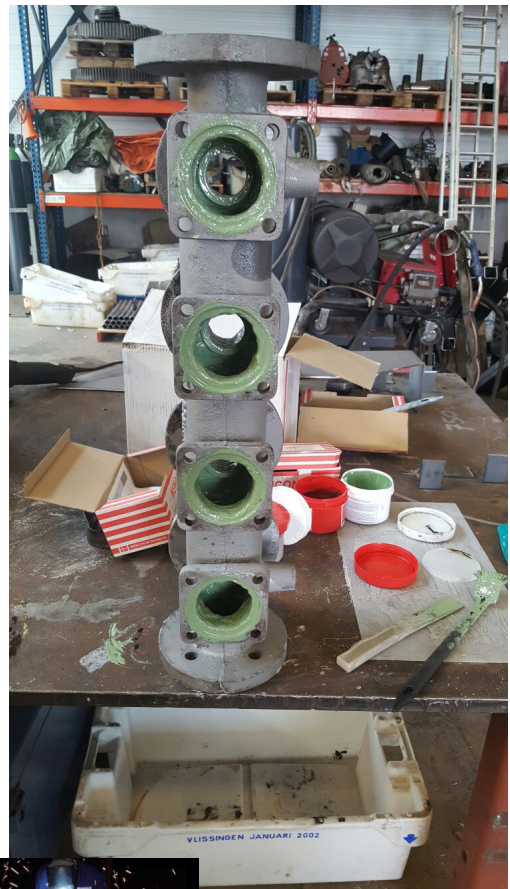
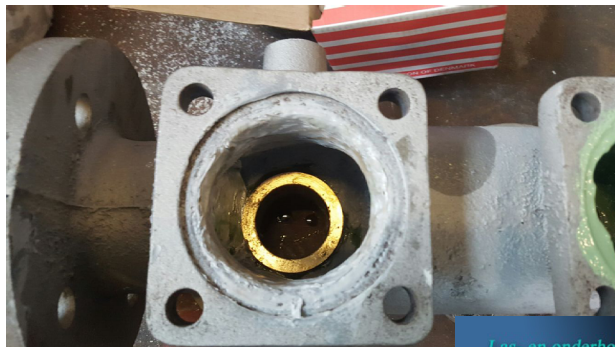
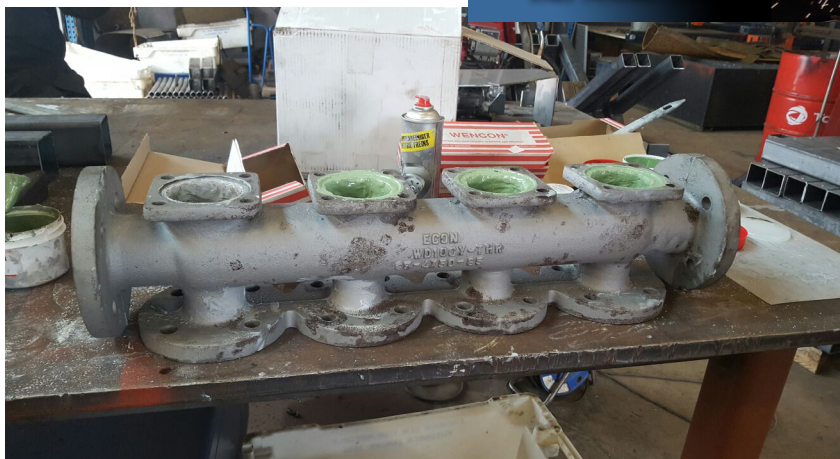
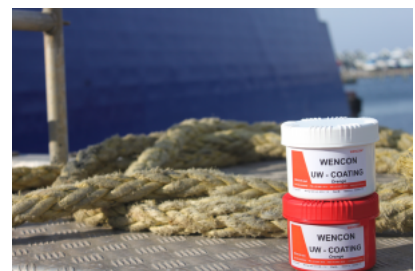
Valve Manifolds or distributor cases are used on many fishing vessels. Body is made from Cast Iron and a major problem is galvanic corrosion. Manifolds are available in 2, 3 and 4 valve bodys with 2 opposed side connections that are one size larger than the valve size.

In this case the manifold was leaking due to the galvanic corrosion and lead time of the new part is approx. 6 weeks. Damaged manifold is disassembled and shot-blasted. Housing is heated to sweat out the salt. After an extra cleaning with the Wencon Cleaner, deep pittings are filled with Wencon UW Cream. New bronze bushings are machined and glued in with Wencon UW Cream, also the rest of the internal surface is coated with the UW Coating. The choice for this product is because of the enormous adhesion of this specific Wencon product. After curing the manifold is assembled and installed on the vessel. The vessel can now continue sailing until the new Valve Manifold is delivered. This so named emergency repair with Wencon products will hold much longer than in this case is needed but offers extra security to withstand the harsh marine environment.
