OFFSHORE EXAMPLES

Mascoat coatings' resistance to moisture eliminates the risk of corrosion under insulation. Also with our coatings you have a space-saving option that reduces topside weight when compared to convention insulation. Below are a few examples of offshore applications.

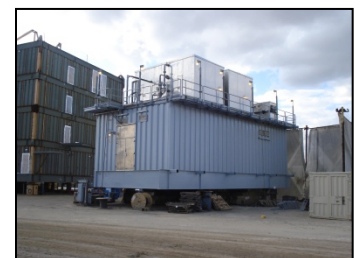
Company: Shell
Platform: Perdido

This platform had an issue with radiant heat gain as well as process heat transferring into crew quarters and other areas. This problem combined with serious weight constraints, made Mascoat Marine-DTM an easy choice.

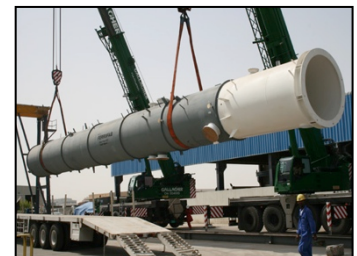
Company: Chevron Offshore
Equipment: Amine Still Column and Reboiler

The specific process equipment operates at temperatures up to 265°F (129°C.) Mascoat Industrial-DTI was able to effectively replace 2" (50mm) of calcium silicate, thereby eliminating the risk of CUI and reducing the overall weight.

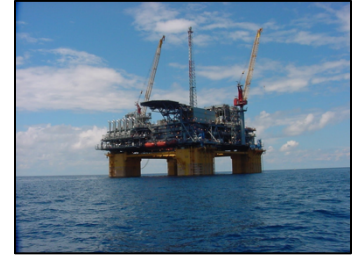
Company: BP
Platform: NaKika

120 mils of Mascoat Marine-DTM was installed to the underside of skids on this platform to reduced condensation forming and reduce energy usage (air conditioning) in the crew space. Initially, the specification was for 7" of cellular glass.
