Cooling water Pipe Repair

WENCON METHOD LARGE COOLING WATER PIPE REPAIR

JOB CARRIED OUT BY MINDERHOUD TECHNIEK VLISSINGEN

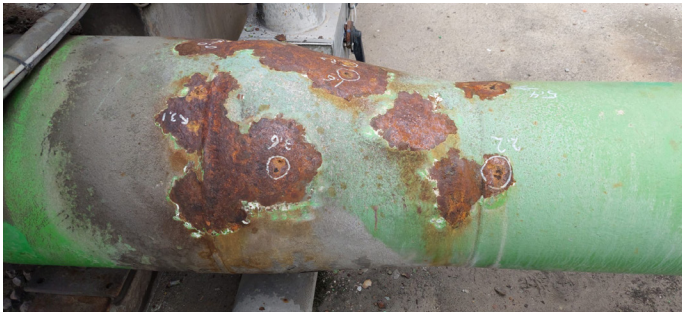
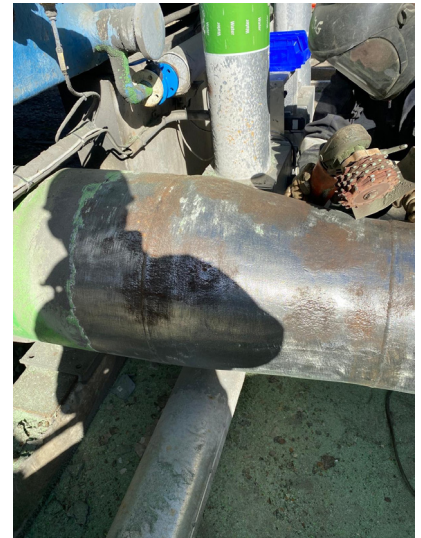
Surface preparation:

Leaks are found in 2 different cooling water pipes. One with a temperature of 70°C and a return line with a temperature of approx. 25°C. With Wencon UW Coating in combination with Wencon Reinforcement Tape there is a strong shell made around the pipe over the entire corroded length. With this method you build a strong Epoxy Plastic Pipe around the steel pipe. The holes are first covered with some Wencon UW Putty to prevent coating is dripping into the pipe. This kind of corrosion is often visible when pipes (especially warm or hot surface pipes) are covered with insulation wool. The wool gets wet and in combination with temperature the right conditions are created for corrosion to occur. In this case it is very plausible that some cavitation inside parts of the pipe caused the leaks and created the corrosion at the surface of the steel pipes under the insulation material.

Clean the surface thoroughly in this case using a Tercoo Disc. The surface reach the same level of purity as shot blasting SA2,5 with a roughness profile of 75 micron. Degrease extra using the Wencon Bio-Cleaner.
