# Fish Waste Basin repair

#### **WENCON METHODE FISH DISPOSAL BASIN REPAIR**

The basin was heavily damaged by corrosion. Harmed by seawater and fish disposal destroyed the bottom of the trough. Also several damages are visible on the sides of the trough.

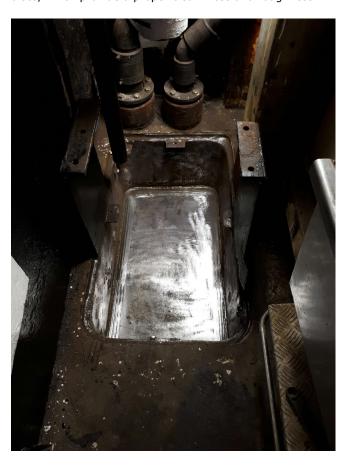
#### **Surface preparation:**

Clean the surface thoroughly using for example the Tercoo discs, which provide a proper cleanliness and roughness.

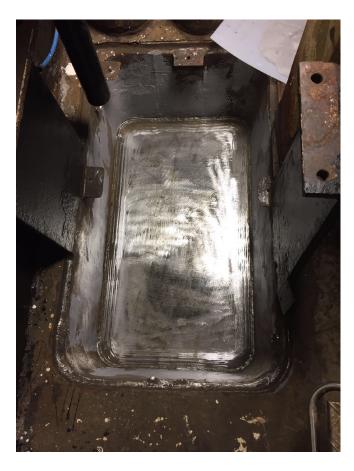
### Extra cleaning:

Offshore cleaner and water or Wencon Cleaner or Alcohol, used to degrease the surface before applying the Wencon products to ensure a good adhesion to the surface.

### **Bottom:**

A double plate of steel is weld in the bottom to get a new strong bottom. Plate surface is cleaned with the Tercoo disc to reach the right roughness. Damages in the wall are filled with **Wencon Cream**.

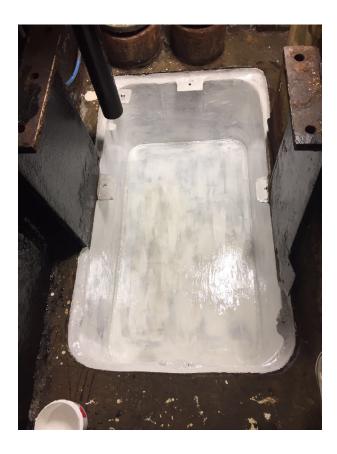
#### **Application first layer:**

When the surface is dry apply the Wencon Coating White with a brush. 300 microns for the first layer. Let is semi-cure for a good adhesion of the second final layer.

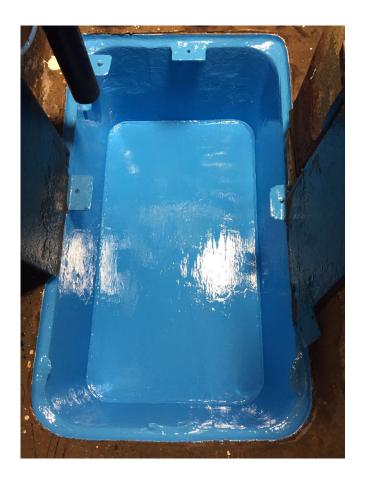
#### Second final layer:

Over the semi-cured first layer coating the Wencon Coating Blue is applied in a layer thickness of 300 micron. After curing the basin is well protected against seawater and ready for service.
